## Excavations at Sisupalgarh, 2008

R.K. Mohanty and Monica L. Smith<sup>1</sup>

### Abstract

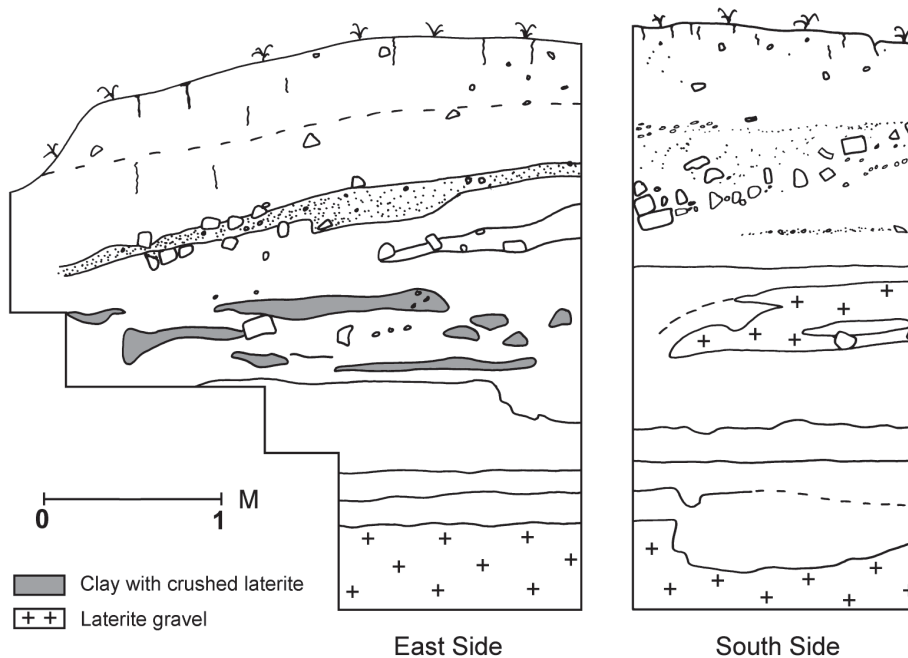
Fig. 2: Upper section of rampart excavation, 2008

The section showed that there were many successive layers of rampart augmentation throughout the site's lifespan (Fig. 2). Although the 2007 excavations of the adjacent rampart strip had shown that there was substantial baked-brick architecture at the apex of the rampart, the remainder of the rampart fill as seen in the 2008 trench mostly consisted of simple earthen filling with very few fragments of bricks. Several laterite blocks in the 25 cm size range were also recovered in the trench, although these were not articulated into any kind of architectural arrangement. Towards the bottom of the sequence there

was a pronounced layer of red laterite gravel interspersed with bands of grey clay. Our excavations show that the area of the ancient rampart continues to slope downwards under the adjacent fields. The observation that the full height and width of the rampart is still unknown has implications for calculating rampart volume on the basis of the current configuration; clearly the rampart was much larger than the area that we currently see in this still-impressive structure.

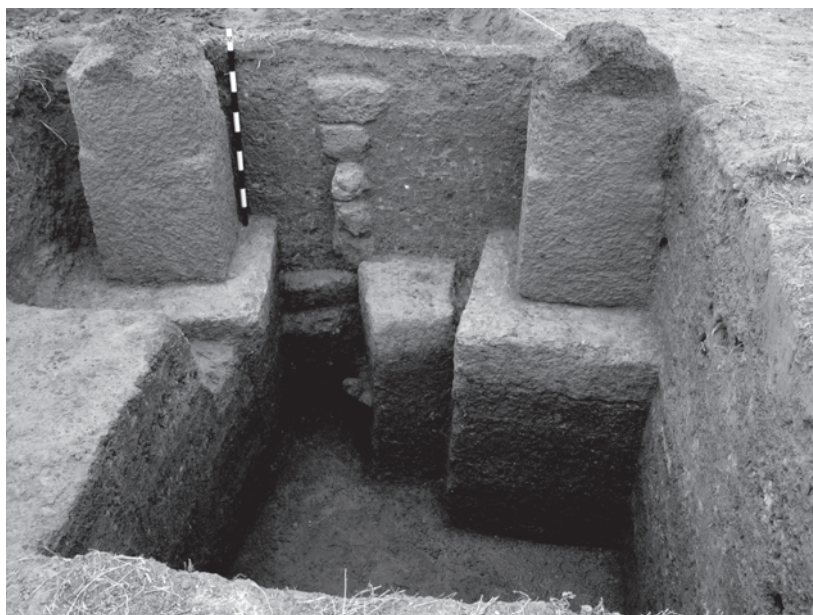
Fig. 3: Trial trench of 2007, reopened and excavated to a greater depth in 2008

Towards the end of the 2007 field season, we excavated a 3 x 3 m trial trench on the upper portion of the mound and recovered the bases of two additional pillars (Fig. 3). Based on this trial trench we recognized that there might be many more as-yet unknown pillars that remain buried. In the beginning of the 2008 season, we again investigated this area and opened several trenches on the pillar mound to achieve both horizontal and vertical exposure (Fig. 4). The excavation was undertaken to address three specific research questions: to find out the architectural form represented by the current standing pillars, to discern whether the pillar mound's elevation preserved intact occupational or use-life deposits compared to the lower-lying and often waterlogged habitation areas investigated elsewhere, and to determine the use of the area prior to the development of the pillar architecture.

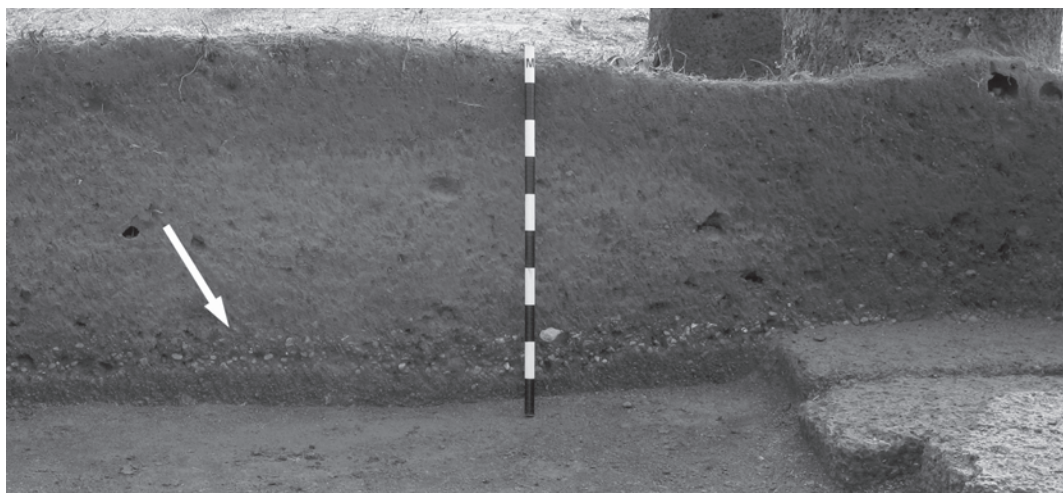
Fig. 5: Layer of quartzite pebbles adjacent to pillars, probably representative of a floor

At 80 cm below the top of the mound, excavation revealed the presence of several thousand quartzite pebbles in a 10-15 cm thick layer that appear to correspond to a floor or flooring preparation throughout the area of the standing pillars (Fig. 5). Adjacent to one of the still-

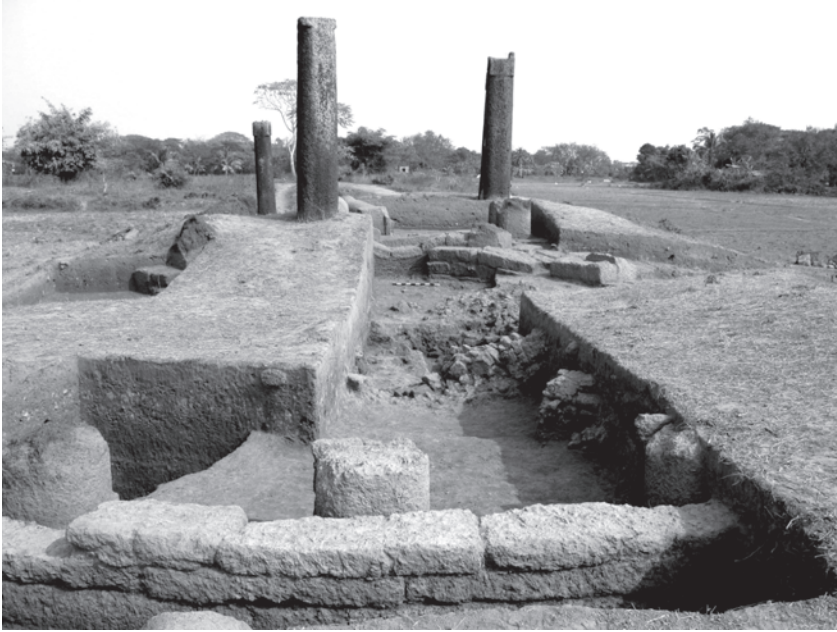
Fig. 6: Western side of circular pillar arrangement, view to east

The 2008 excavations showed that the long-standing and newly-exposed laterite pillars revealed an arrangement that was a combination of rows and a circle (Figs. 6 and 7). Prior to excavation the area that turned out to be circular had a very slight inward slope as though shaped like a shallow bowl. The upper fill of this area was also extremely silty and contained no artefacts. The removal of the silty material revealed a fill of brick and tile fragments in a compact arrangement. Further investigation showed the presence of what appears to have been a brick construction that collapsed inwards. This brick construction was not fully exposed in the 2008 season but appears to have been relatively small, in the range of 2 to 2.5 m in diameter, with a central area of the collapse containing a very sandy and comparative loose material. There was no pottery in this sandy material, and the bricks exposed in this central portion of the circle appear to have simply fallen into place without subsequent disruption or robbing.

of pillars was an area of pillars measuring 60-62 cm in diameter arranged in a circular pattern. Those pillars also were surrounded by a curved wall that suggested a circular or apsidal structure of at least two building phases. The expertise required to cut, transport and erect the pillars, many of which were over 4 m in length, would have been very impressive in any era but particularly in a pre-mechanical age. It is not yet clear what the underlying structural support of the pillars consisted of, and whether the pillars were lowered into a socket. In any case given the great weight of the pillars it is rather remarkable that many of them remain standing.

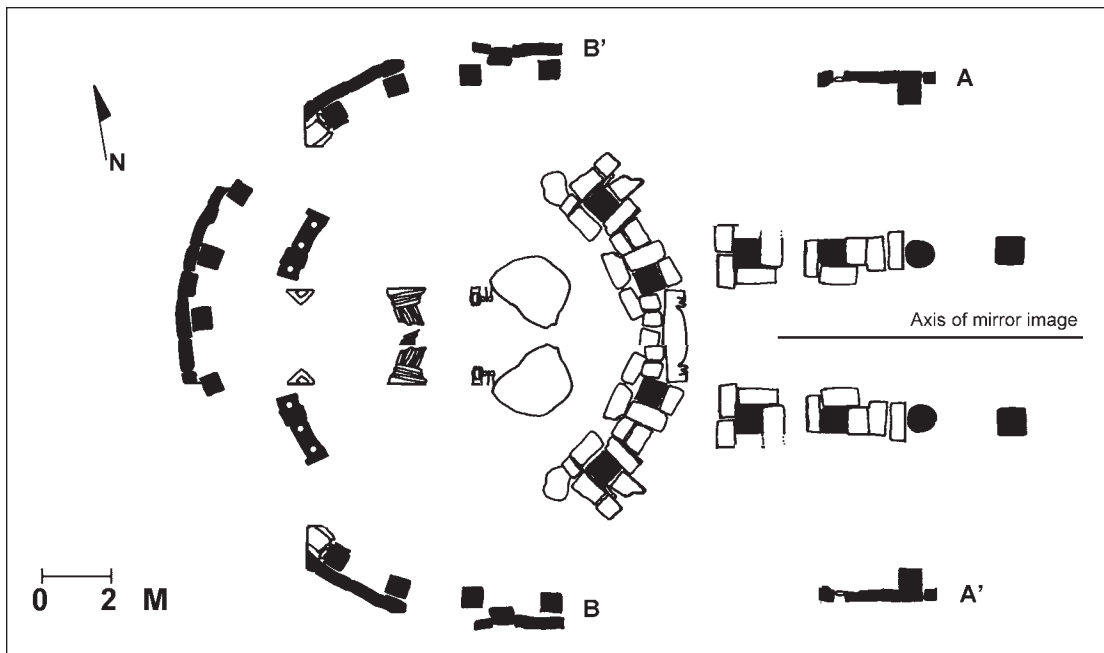
Fig. 7: Hypothetical reconstruction of pillar mound construction on the basis of standing pillars and excavated pillar fragments. The image was created by assuming that the long axis of the paired pillars on the right hand permits a reconstruction of the distribution of pillars and other architecture. Our 2008 excavations were copied on either side of the axis to create this image (for example, A is an excavated area and A' is its mirror-image copy on the other side of the axis. Similarly, B was excavated and B' is its mirror-image copy).

In total, the excavation team recovered the remains of pillar bases and fragments representing 18 previously-unknown pillars. The configuration of the structure appears to include a long entryway of paired monumental pillars of 72-74 cm diameter. On the western side of these two rows

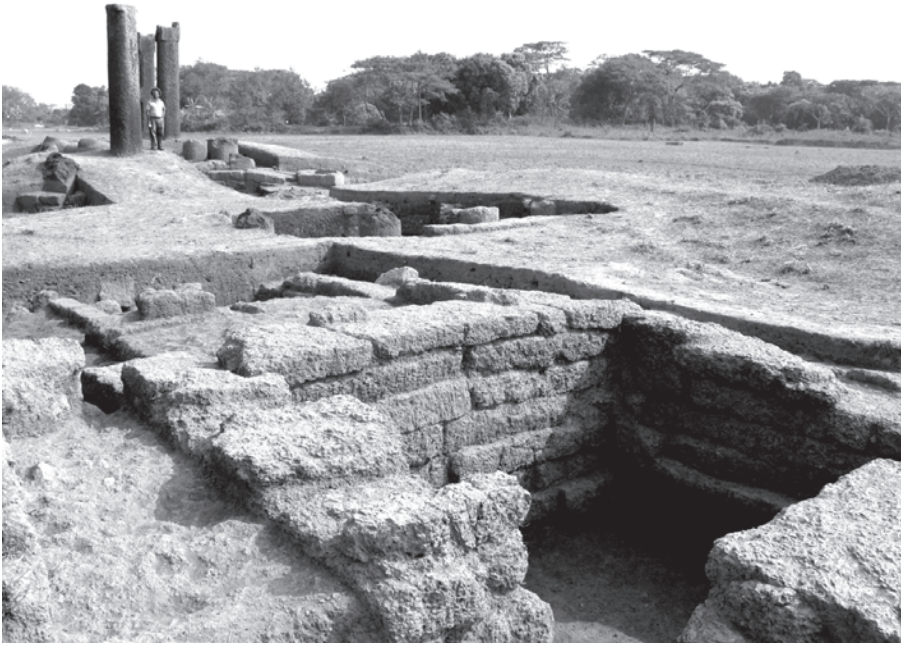
Fig. 8: Room PL11 in large rectilinear structure adjacent to pillars

One of the rooms (PL11) was excavated completely, revealing up to seven courses of laterite blocks (Fig. 8). This “room” had very compact fill which suggests that it was a packed foundation for a taller facility. The compacted fill was not the simple result of deposits settling naturally, as the fill became looser towards the bottom of the room, just above the lowest of the seven courses of laterite blocks. The fill was primarily very compact laterite gravel but there were occasional displaced fragments of laterite and chunks of plaster at odd angles. This suggests that plaster flooring had already been used in the vicinity of the pillar mound long enough to become discarded and suitable for building fill by the time of the construction of the room PL11. One analogue to the very robust architecture of the PL11 room might be found in the excavated gateway on the western side of the site, where numerous courses of laterite blocks were stacked up to form the passageway (Lal 1949). The builders of the PL11 room appear to have had less concern with overall stability, as the stones of the walls were laid in a non-overlapping manner. The structure thus achieved stability through the sheer mass of the architectural elements.

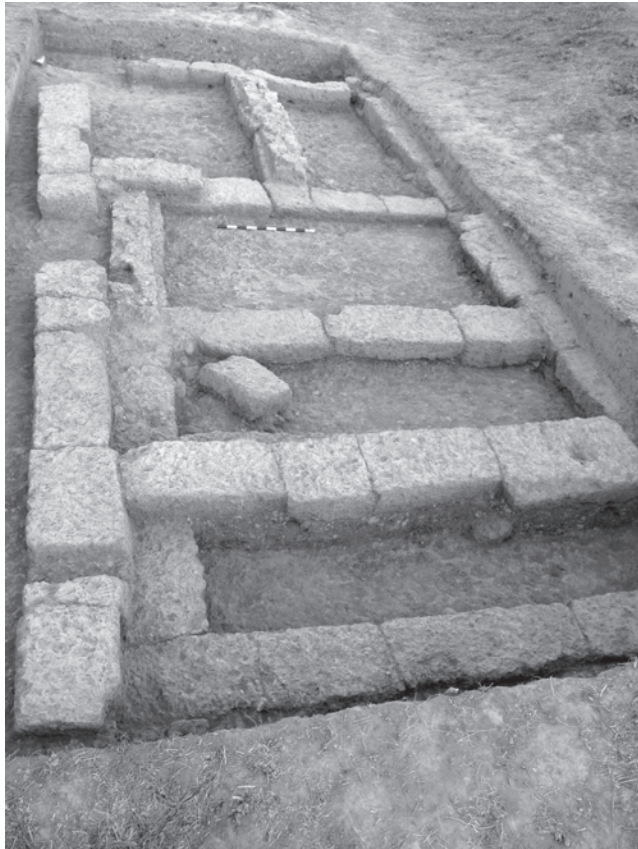
Fig. 9: Rectilinear structure on western portion of the pillar mound

In the western portion of the mound and 30 m from the pillars was a slight rise that appeared after vegetation clearance to be the location of intact structural remains. Excavation in this area revealed a structure made of laterite blocks and bricks divided into several small rooms, some of which measured as small as 0.8 x 3.05 m (Fig. 9). The laterite blocks of the structure appear to have had two phases of construction, with carefully laid blocks of similar size on the bottom, followed by a later addition of irregular blocks with less care in placement. In some cases there was brick on top of laterite block, similar to the style of construction found in the upper layers of the Operation 1 habitation area on the western portion of the site and the Operation 3 habitation area on the northern part of the site (see previous excavation reports). However, in the case of the pillar mound structure, the brick is somewhat better preserved, with two courses of bricks over the laterite block.
